# IMPACT OF FOULING ON PERFORMANCE OF DIFFERENT HFF MEMBRANES OPERATED AT DIFFERENT COASTS<sup>1</sup>

## ABSTRACT

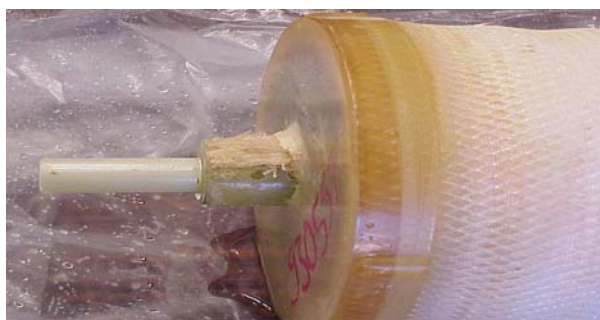
Figure 1 shows that the permeate tube of CTA membrane is protruding out from the membrane module after breaking the epoxy seal. Also, the membrane has been subjected to compressive force as can be seen from the folds developed on the membrane as shown in Figures 2.

**Figure 1. View of permeate tube protrusion of CTA membrane**

Thus, it is clearly evident that there had been leak of feed seawater through this broken portion of epoxy, which made the feed to leak out through this broken path and mix with brine resulting in very little feed water actually getting through the membrane. This naturally increased recovery for this particular membrane, which forced the membrane to produce a permeate of poor quality as well as quantity. It was also found that (Figure 3) the outer membrane fibers were very clean with pure white color indicating possible bleaching due to chlorine.

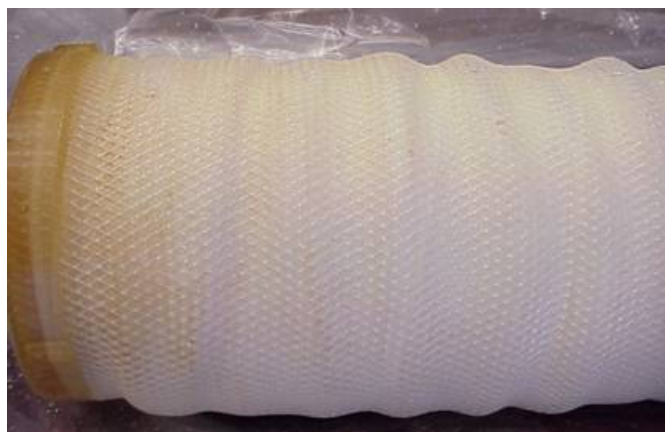
**Figure 2. View of folds developed on the CTA membrane**

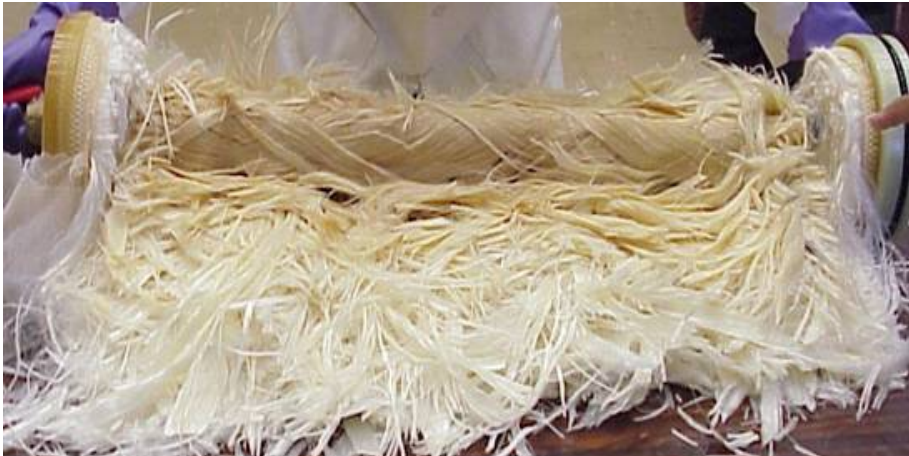
However, the inner fibers, i.e., the fibers closer to membrane feed tube are found to be yellowish brown in color, which was intense for the fibers closer to the feed tube, indicating some sort of foulant adhesion on these fibers. The color diminishes gradually towards the outer fibers. This is a typical situation of HFF membrane fouled by foulants of colloidal and/or biological in nature. Moreover, a black stain was visible (Figure 4) closer to the feed tube, which is suspected to be biologically active.

**Figure 3. View of autopsied CTA membrane showing the color difference among the fibers**

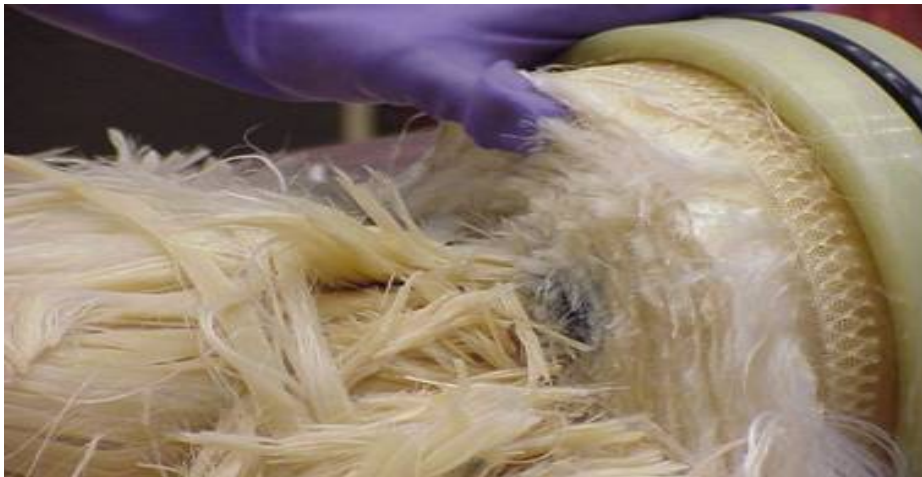
Sulfate-reducing bacteria (SRB) were isolated from the black region of the CTA membrane (Figure 4) but not from the brown one. The brown region revealed a heavy and highly pure growth of bacterium. The isolate was a gram negative rod which was positive for the following reactions: Motility, Oxidase, Catalase, Arginine, Citrate, Glycogen, Acetic acid, Citric acid, Formic acid, Lactic and Propionic acid. The isolate grew in a pH range of 5 – 10, salinity of 0.5 – 90 ppt and a temperature range of 10 – 40 °C. It grew in media containing 250 ppm but not in 500 ppm formaldehyde. Growth was also positive following 15 min. exposure to 1 mg/L chlorine and 2 – h exposure to 0.5 mg/L chlorine. The isolate belongs to the genus *Pseudomonas* in the cluster *Pseudomonas mendocina-alkaligenes-pseudoalkaligenes – stutzeri – balearica* and is phenotypically most related to the species *Pseudomonas Mendocina*. It can be summarized that formaldehyde preservative would be insufficient below a concentration of 500 ppm. Also, the bacterium was found to adapt well to chlorination and thus chlorine-tolerant membranes are equally susceptible to biofouling as their chlorine – sensitive counterparts.

**Figure 4. View of autopsied CTA membrane showing a black colored stain near the feed tube**

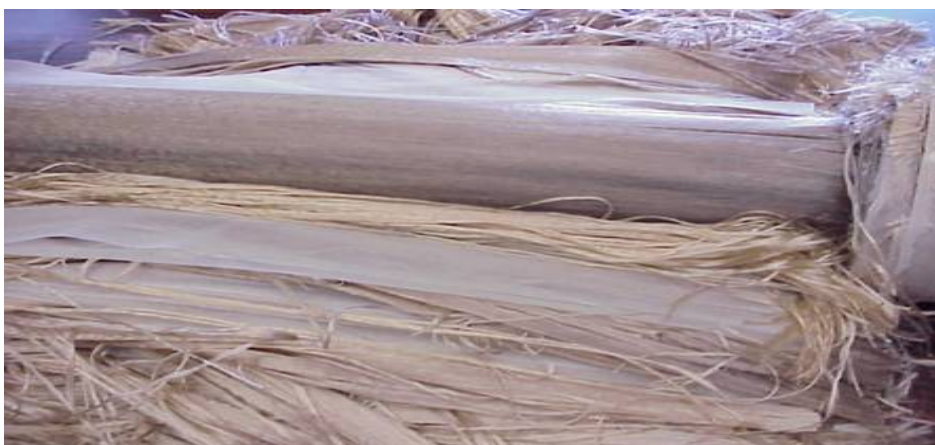
During visual inspection of the PA membrane bundle (Figure 5), the outer membrane fibers appeared to be very clean, retaining the original bright golden brown color of virgin membrane fibers, indicating absence of any foulants on these fibers. However, the inner fibers, i.e., the fibers close to membrane feed tube, were found to be dark brown in color, which was very intense for the fibers nearer to the feed tube. These fibers were also found to be bound together, indicating possible foulant deposits on these fibers close to the feed tube.

**Figure 5. View of autopsied PA membrane showing the color difference among the fibers**

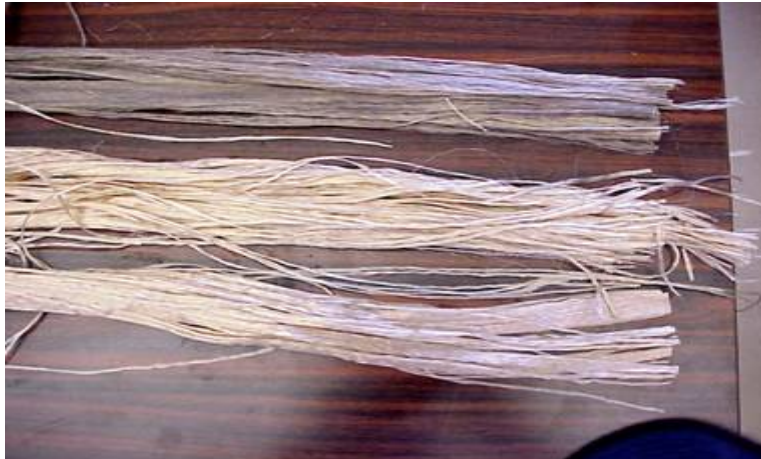
Figure 6 shows difference in color of fibers removed from outer, middle and inner portion of the membrane bundle. It can be seen that dark brown color gradually becomes more intense towards the inner fibers. This is typical situation of an HFF membrane fouled by colloidal and/or biological matters. However, the lack of foul odor in the membrane points towards absence of any severe biofouling on that membrane.

**Figure 6. View of PA membrane fibers showing the color difference among the fibers**

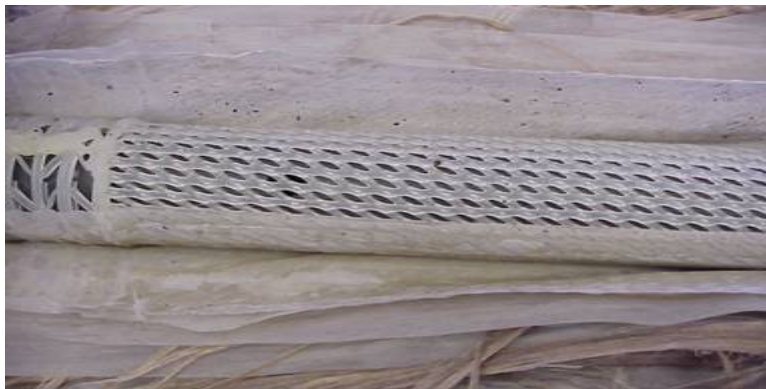
The feed distribution tube was found to be relatively clean (Figure 7) with only a small amount of particles deposited on the reemay (spacer web) close to the feed tube, which might have escaped through the defects in cartridge filter, a common situation [3]. Moreover, no part of the membrane bundle was found to be damaged.

**Figure 7. View of feed distribution tube of autopsied PA membrane**

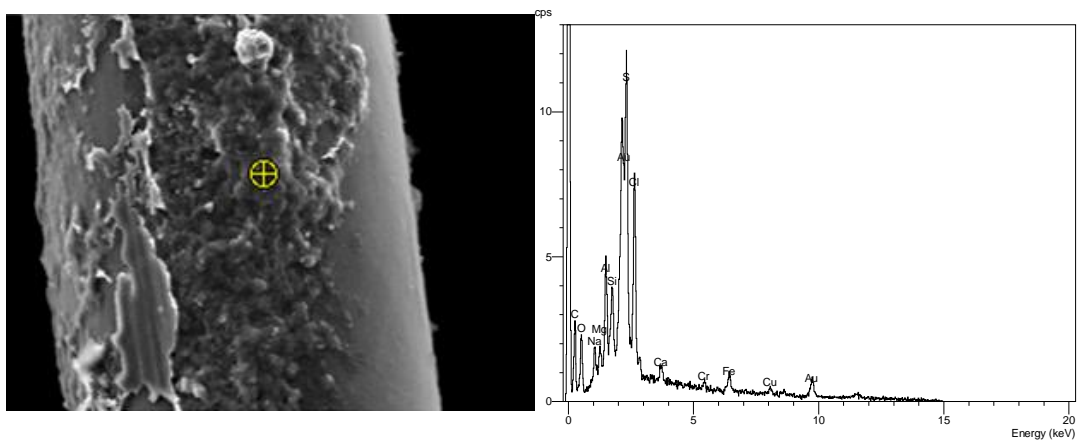
The amount of foulant adhering to the CTA membrane fibers was very small and could not be removed from the fibers' surface for the wet chemical analyses to be done. Hence, SEM and EDX were utilized to identify the foulants adhering to the inner membrane fibers. SEM and EDX analyses were in conformity with visual inspection results as they showed that the inner fibers had much higher foulants on their surface, the outer fibers had the least and the middle fibers had foulants in between that of inner and outer (Figures 8 – 10). The EDX spectrum showed that the foulant mainly constitutes Al, Si, Fe, Cr, and Cu in addition to the inorganic component typically found in seawater such as Ca, Mg, Na, S and Cl.

Presence of C and O could be from membrane itself or due to organic foulant present on the membrane or from carbonates. Occurrence of Si along with Al indicates presence of aluminum silicate. Aluminium silicate is a common foulant and much of it found on membrane deposits is present as silt, clay and other commonly found compounds such as diatomaceous earth formed from algal skeletons [5]. The algae present in the seawater could have been broken into smaller fragments during chlorination and escaped through the media and cartridge filters before reaching the membrane surface. Also presence of Fe along with Cr indicates presence of corrosion products from stainless steel piping. The middle fibers (Figure 9) also contain foulant similar in composition that found on inner fibers. The outer fiber (Figure 10) was found to be very clean and only peaks due to C and O could be seen in the EDX spectra, which of course corresponds to the membrane material and Au peak seen on all the EDX is from the gold coating applied on the sample during the analysis.

**Figure 8. SEM Micrograph and EDX Spectrum of an Inner CTA Membrane Fiber**

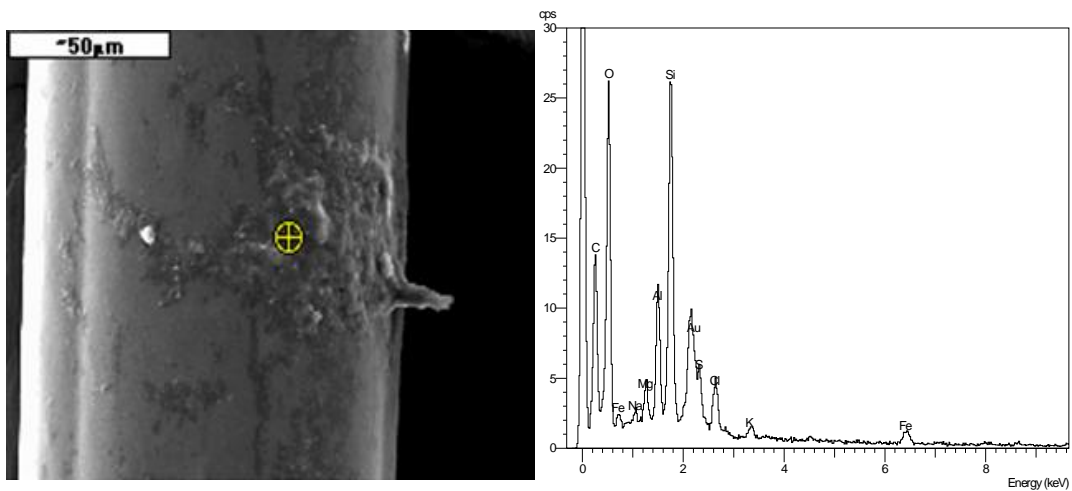
**Figure 9. SEM Micrograph and EDX Spectrum of a Middle CTA Membrane Fiber**

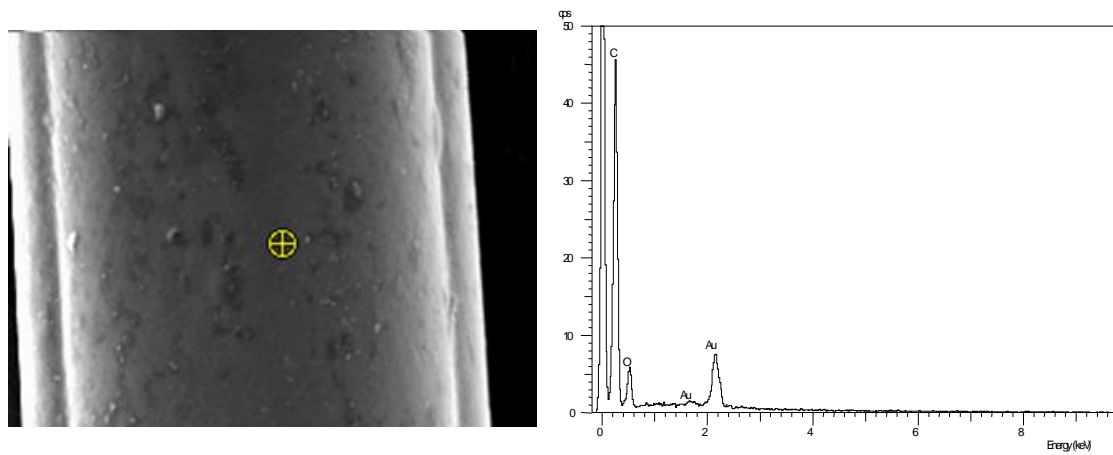
**Figure 10. SEM Micrograph and EDX Spectrum of an Outer CTA Membrane Fiber**

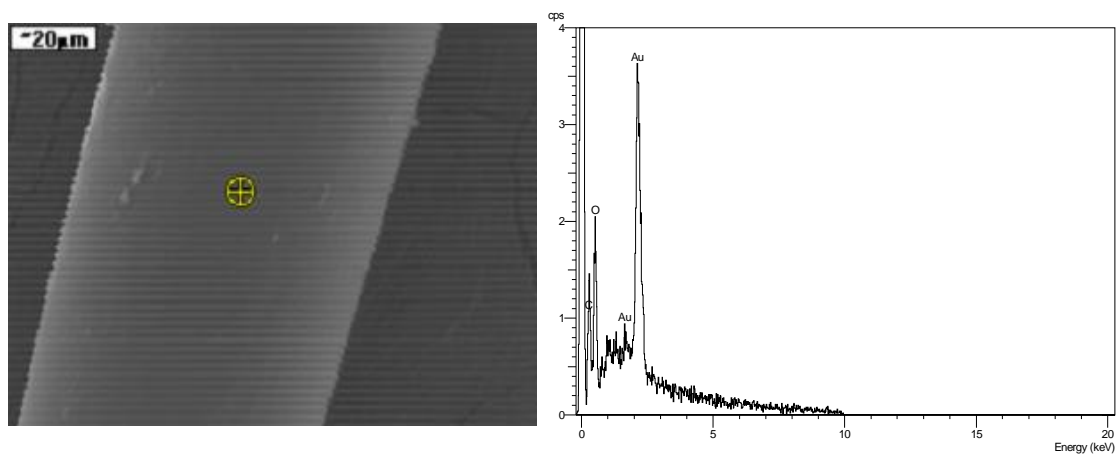
The outer fiber (Figure 11) was found to be very clean and only peaks due to carbon (C) and oxygen (O), could be seen in the EDX spectra, which, of course, corresponds to the membrane material, and the gold (Au) peak seen on all the EDX spectrum is from the gold coating applied on the sample during the analysis. The magnesium (Mg) and sodium (Na) peaks present in the middle fibers could have originated from the seawater itself and the fibers appear to be relatively clean (Figure 12). The inner membrane fibers (Figure 13) found to contain thick foulant deposit on its surface and the EDX spectrum showed that the foulant mainly constitutes C and O that could be from the organic foulant present on the membrane. This clearly indicates that the foulant is biological in nature as confirmed from the presence of sugars and proteins. It is also quite evident from SEM and EDX analyses that no inorganic fouling has taken place on the membrane, and even the iron (Fe), which was used as coagulant ( $\text{FeCl}_3$ ), was not present in any of the membrane fiber surfaces.

**Figure 11. SEM Micrograph and EDX Spectrum of an Outer PA Membrane Fiber**

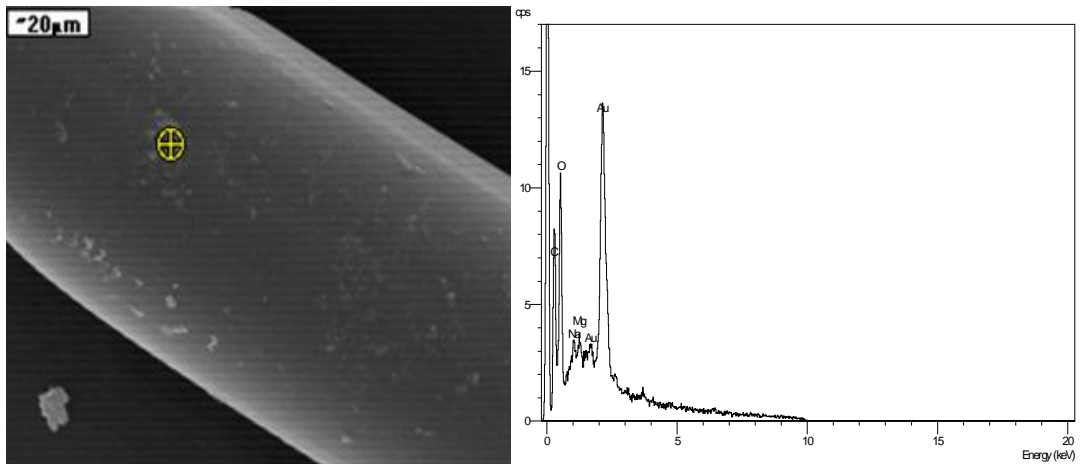
the inner fibers had much higher foulants on their surface, the outer fibers had the least and the middle fibers had foulants in between that of inner and outer fibers (Figures 11 – 13).

**Figure 12. SEM Micrograph and EDX Spectrum of a Middle PA Membrane Fiber**

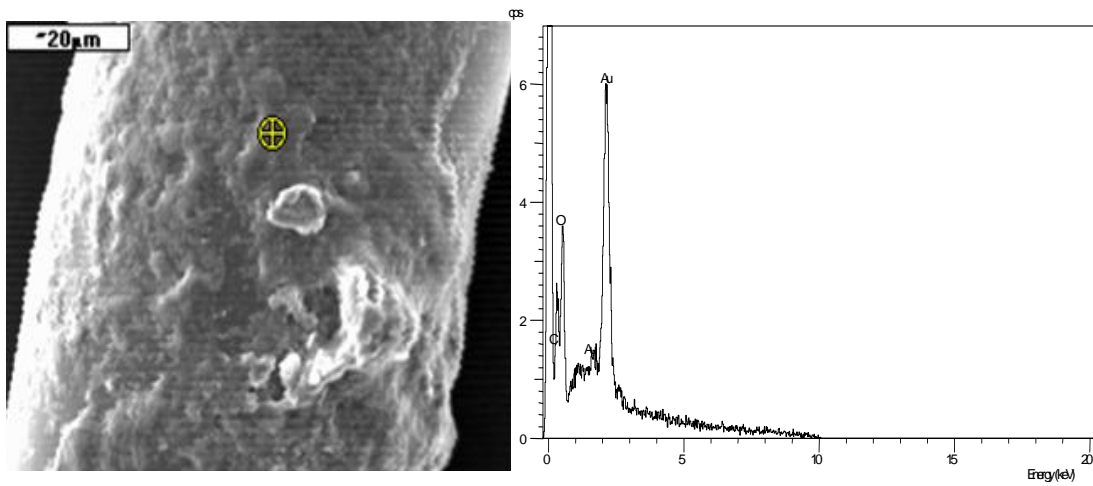
**Figure 13. SEM Micrograph and EDX Spectrum of an Inner PA Membrane Fiber**

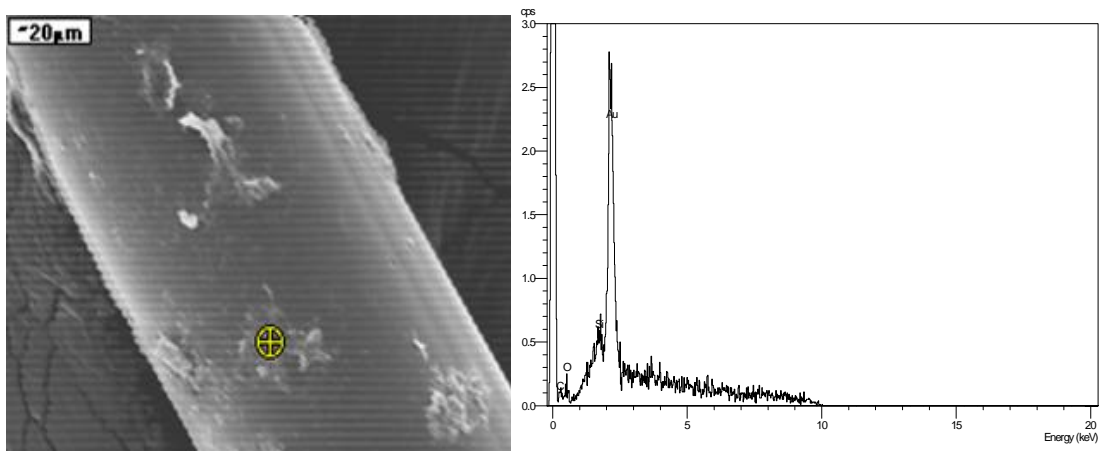
**Figure 14 . SEM Micrograph and EDX Spectrum of an Inner PA Membrane Fiber Cleaned using Caustic (NaOH) Solution at pH = 11**

As an additional experiment, a small amount of inner membrane fibers were immersed in NaOH solution at pH = 11 for 2 hours followed by rinsing with distilled water, and it was found that most of the foulants adhering to the membrane surface were removed, as can be seen from the SEM micrographs (compare Figures 14 and 13). This indicated that the biofilms formed on the membrane fibers are not of a stubborn type and are easily removable by high pH cleaning.

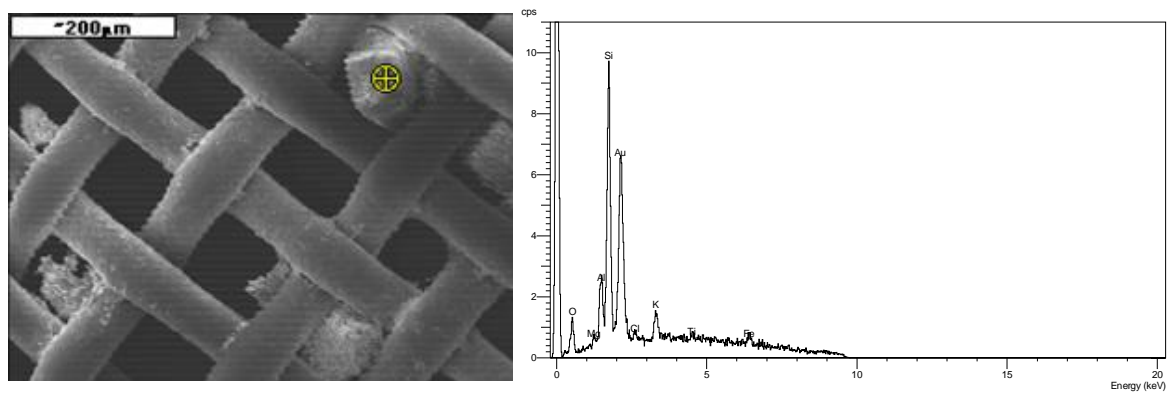
The reemay showed (Figure 15) presence of small particles trapped on it, which mainly consists of silicon (Si), aluminium (Al), Mg and potassium (K) and could originate from silt.

**Figure 15 . SEM Micrograph and EDX Spectrum of a Reemay of PA Membrane**
